# Service Letter

**Bulletin:** 40007  
**Date:** 29 May 2009 Revised (10-12)  
**Product:** Compressors  
**Subject:** 7/41 Wiring harness and battery cable routing/protection

MODELS	SERIAL NUMBER
7/41	418800 → 426380

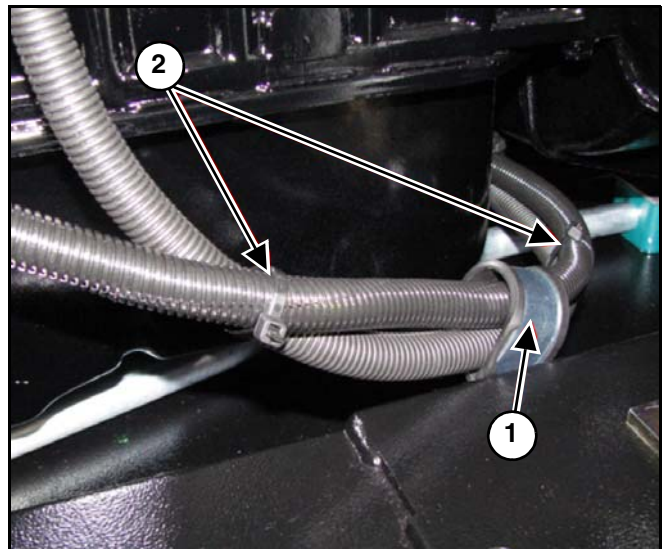
Figure 1

Battery cable and harness have not been routed correctly on some compressors which can lead to a shortcircuit and possible damage to attached components.

1. Turn clamp (item 1) from original position to same as shown. **[Figure 1]**
2. Add tie wraps (item 2) in order to secure both conduits. **[Figure 1]**
