Doosan Infracore
Portable Power

Service Letter

Safety Notice

SL: 30006
Date: 15 February 2012
Product: Generators
Subject: Main Power Cables Inspection (Y05A) / Repair (Y05B)

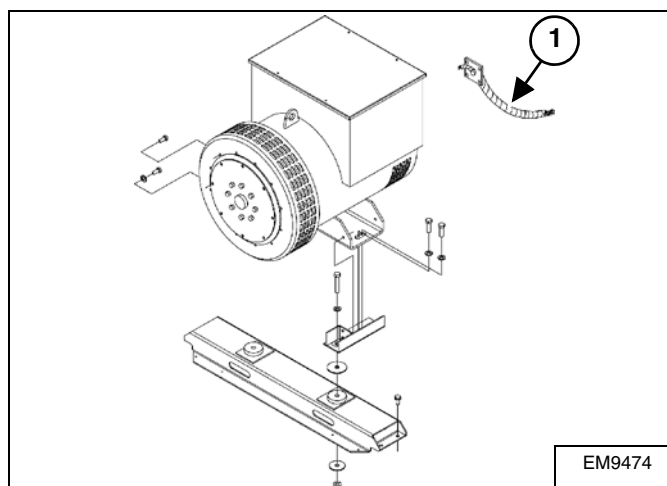
Figure 1

[Figure 1] Doosan Benelux SA has determined that the routing of the main power cables (Item 1) between the alternator box wiring terminals and the circuit breaker may not meet engineering specifications for the generators listed in this letter. Improperly routed main power cables may rub against metal side plates or sharp edges along the way to the main circuit breaker causing a wear of the external insulation layer.

If the main power cable insulation becomes worn off and the exposed copper wire contacts a metal surface, an electrical short may occur. An electrical short may lead to an electric shock hazard and fire resulting in **serious injury or death or property damage.**

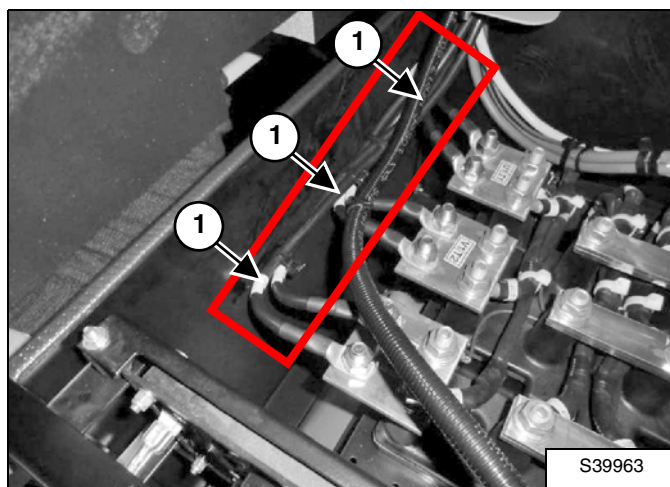
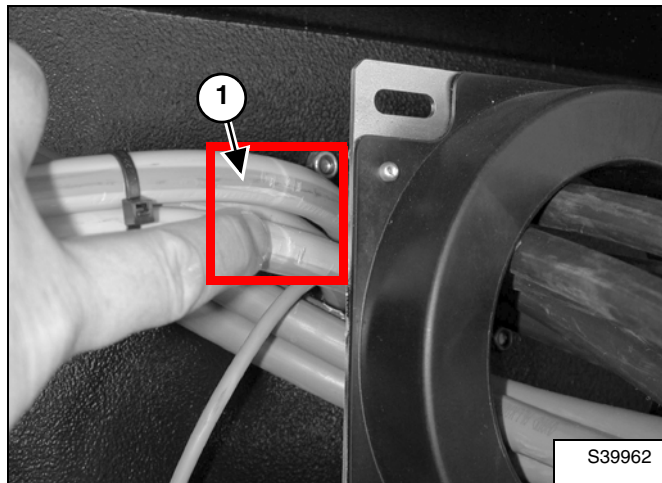
Check the routing of each main power cable (Item 1) [Figure 3] and [Figure 4] and ensure it cannot rub against the side plates, nor any metallic part or edge.

- If the main power cables are touching the terminals box sides or any metallic part or edge, but are not showing any sign of cable insulation damage: **ensure a proper cable routing to avoid any potential contact.**
- If the main power cables are showing any sign of cable insulation damage: **install heat shrink isolation around the affected cable (see repair procedure below). Then re-install the cables ensuring a proper cable routing to avoid any potential contact.**
