## **GENSETS      50 Hz**

**GEN - 003**

**SUBJECT:**              Damaged wires & insulation inside Alternator Junction box

**MODELS AFFECTED:**      G22 and G33              50 Hz

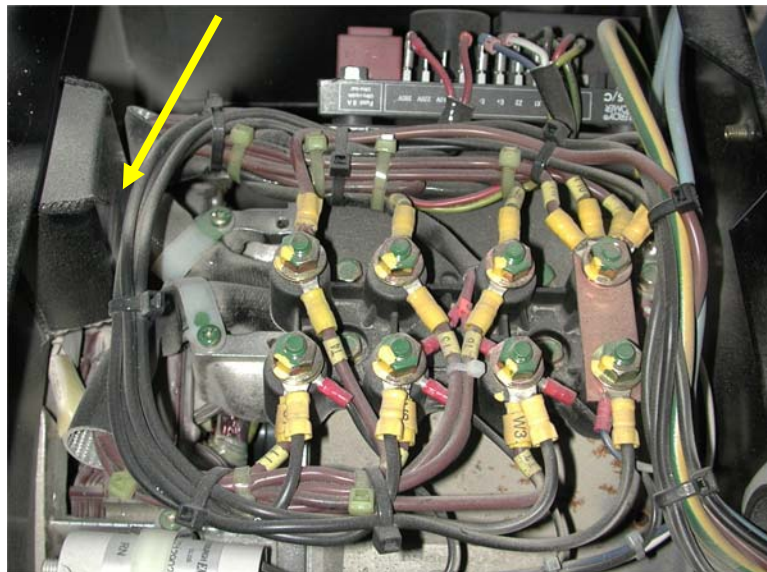
**SYMPTOMS:**      **Excessive wear or short circuiting of wiring inside Junction box on the Alternator**

**CAUSE:**              Loose or improperly routed wire inside the Junction box

**REMEDY:**              Check wiring inside Junction box for proper fit and condition at each service or at maximum interval of 1000 hrs,

**ACTION:**              Secure and reroute all loose wires or those found to be rubbing against any part of the Junction box (particularly the part arrowed), with tie wraps (zip ties) or other proper mounting hardware. Replace any damaged wire, or any wire with damaged insulation.
