Bulletin #: LT-2006-001 **Date:** 16/05/06

Subject: LT6 mast top sensor wire routing improvement

LT6

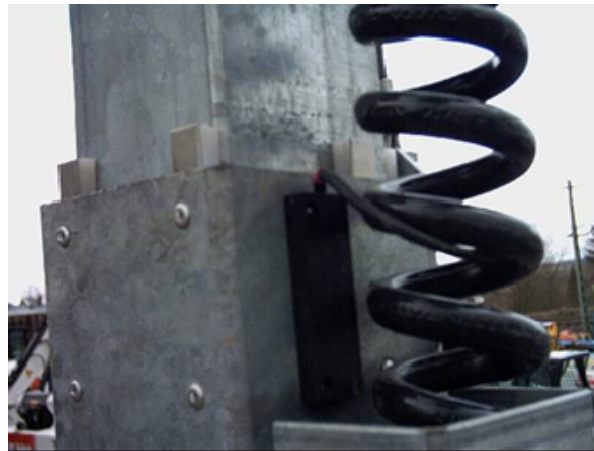
Picture 1

It has been noted that the main light cable could damage the mast top sensor wire during operation of the mast as shown in Picture 1.
