Portable Power

PC-12-12
July 15, 2003
Revised (10-12)

GENSETS

SUBJECT: Incorrect location of brake control wire on 6 way plug for trailers

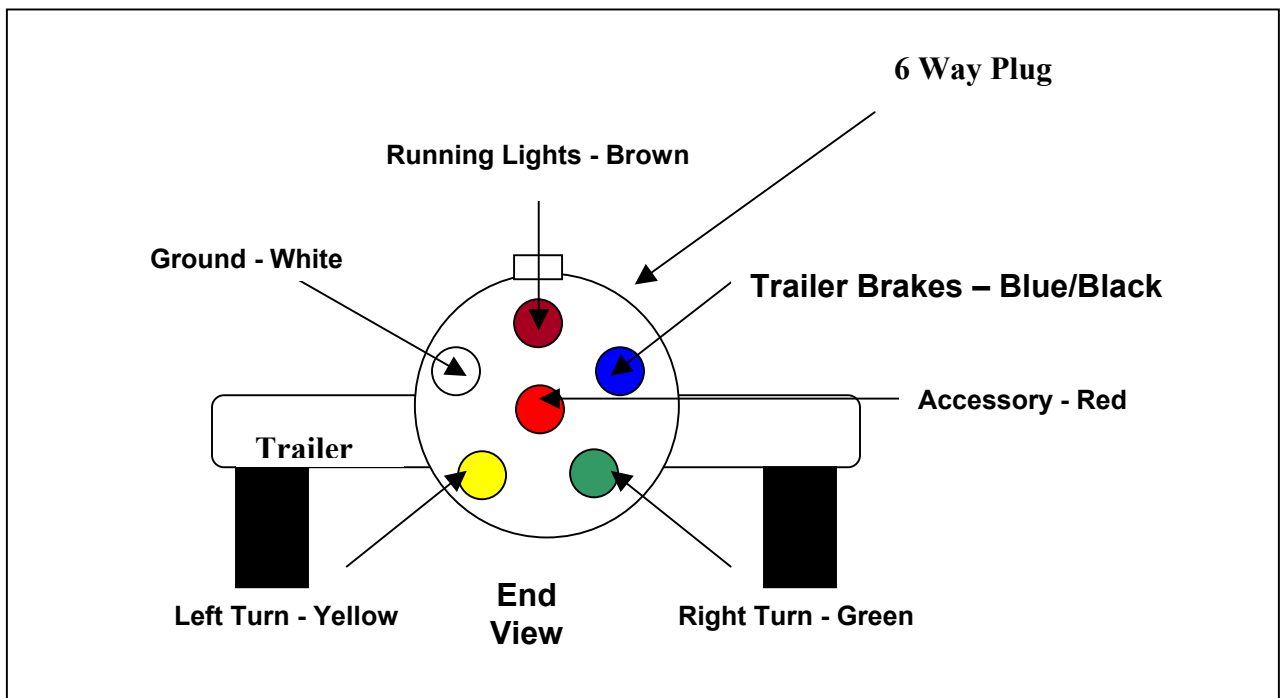
Trailer Connector 6-way Plug Wiring

SYMPTOMS: Brakes lock up even though tow vehicles brakes are not applied

CAUSE: Brake control wire located on wrong pin of six way plug

REMEDY: Install brake control wire to correct pin location in harness connector.

ACTION: Relocate connector wiring per the drawing below.
