Technical Service Bulletin

Number: PC12-20

Subject: Incorrect location of Fuel pump wiring and adding a fuse to the circuit

INDUSTRIAL GENSET MODELS S40 through S200

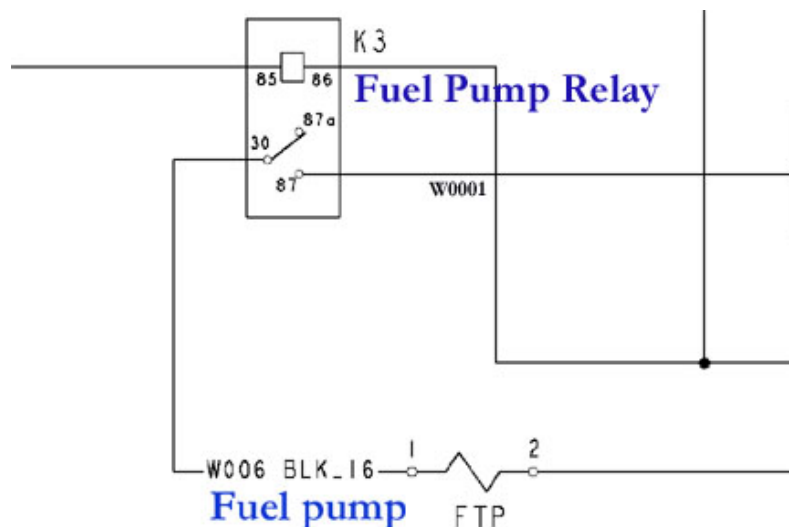
SYMPTOMS: Fuel pump may run when unit is off line.

CAUSE: Power wire to fuel pump may be connected to the wrong pin on the fuel pump relay.

REMEDY: 1. Check wiring at fuel pump relay K3, the W001 wire should be located on pin 87 of the K3 relay not pin 87a. correct if required. 2. Order and install fuse kit IR CPN 22595938 on circuit as shown in the instructions provided with the kit.
