Technical Service Bulletin

Number: PC12-24

Subject: Removing K2 relay from control panel

MODELS AFFECTED: INDUSTRIAL GENSET MODELS N25 through N130 **with a K2 relay in lower area of Control Panel**

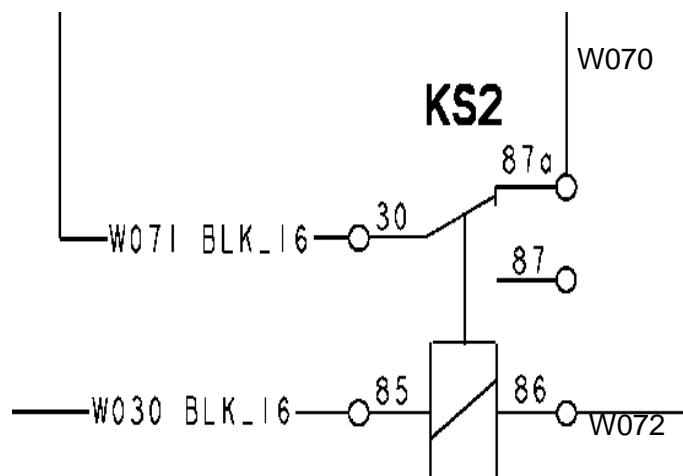
SYMPTOMS: Unit will not start after sitting idle or in Auto for more than 6 hours.

CAUSE: K2 relay is applying constant power to engine ECU.

REMEDY: 1. Please remove K2 relay from the Circuit (located in the bottom of the control panel pedestal), tie up wires and make note to units modifications, as there will be an update to be performed on these units at a later date. **Please note this will disable the water temp readings on the unit when it is not running, and may result in a water temp alarm upon starting.**
