Technical Service Bulletin

Number: PC12-25

Date: February 13, 2006 **Revised (10-12)**

Subject: Removing K2 relay from control panel

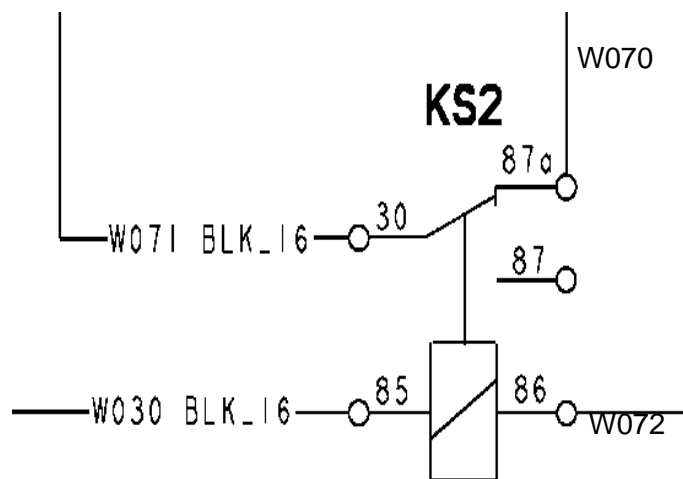
SYMPTOMS: Unit will not start after sitting idle or in Auto for more than 6 hours.

CAUSE: K2 relay is applying constant power to engine ECU.

REMEDY: 1. Please remove K2 relay from the Circuit (located in the bottom of the control panel pedestal), tie up wires. **Please note this will disable the water temp readings on the unit when it is not running, and may result in a water temp alarm upon starting, this will be the permanent solution to this issue. If K 2 is not present no action needs to be taken.**
