## Technical Service Bulletin

**Number:** PC12-26

**Subject:** Removing K4 relay from control panel

**MODELS AFFECTED:** TELECOM GENSET MODELS N40 through N60 **with a K4 relay in lower area of Control Panel**

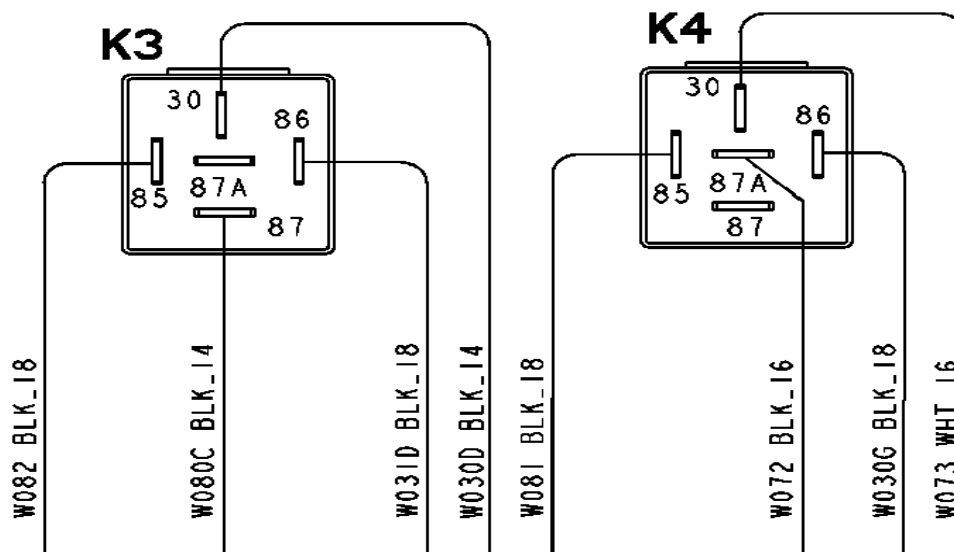
**SYMPTOMS:** Unit will not start after sitting idle or in Auto for more than 6 hours.

**CAUSE:** K4 relay is applying constant power to engine ECU.

**REMEDY:** 1. Remove K4 relay from the Circuit (located in the bottom of the control panel pedestal), tie up wires. **Please note this will disable the water temp readings on the unit when it is not running and may result in a water temp alarm upon starting, this is the permanent solution to this issue. If K 4 is not present no action needs to be taken.**
