**Number:** PC12-028

**Subject:** Improper wire routing in J box, loose connections on Studs.

## Technical Service Bulletin

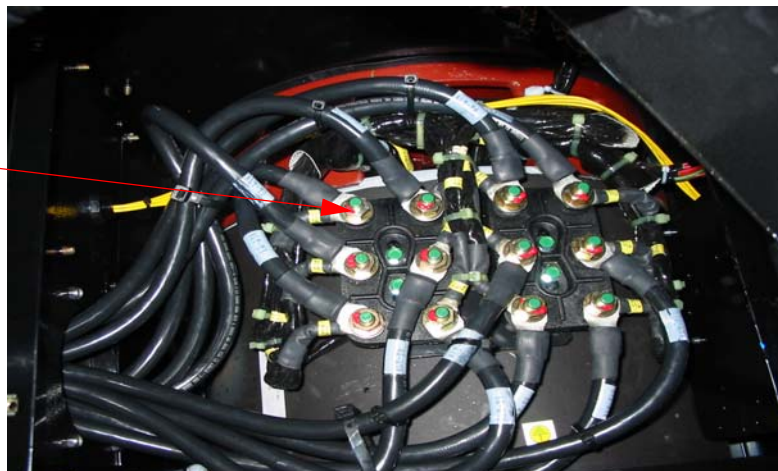
The above models may have generator wiring improperly routed and can rub metal areas in J Box and short out, also nuts on studs could be loose, causing shorting as well.

Check for loose stud nuts and unsecured wires in J box when performing next service.

Route wires as shown in picture below, torque Nuts on studs for G25B-40B to 19ft lbs, models G60, 80A, G125A to 38 ft lbs. This is not a Campaign, this is for information only

Stud nuts to be torqued to spec, route wires and secure as shown
