Number: PC12-031

Technical Service Bulletin

Subject: installing a new AC Alternator in a Powersource Genset requires special attention to the new alternator sensing wires and load studs.

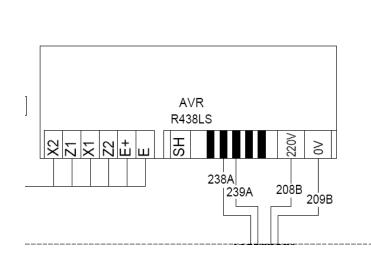
When replacing the original AC Alternator, there may be additional sensing wires on the voltage regulator and copper buss bars on the studs that should be removed.

Caution Failure to assure correct sensing wire and copper buss bar connections will damage the new AC alternator.

When connecting the wiring to the AVR, only the wires shown below should be on the AVR, all others should be removed from the AVR and secured. When connecting the T wires to the studs, remove all copper buss bars connecting studs to each other.
