## Technical Service Bulletin

**Number:** PC12-036

**Subject:** Engine harness wiring on John Deere ECU (pins pulling out)

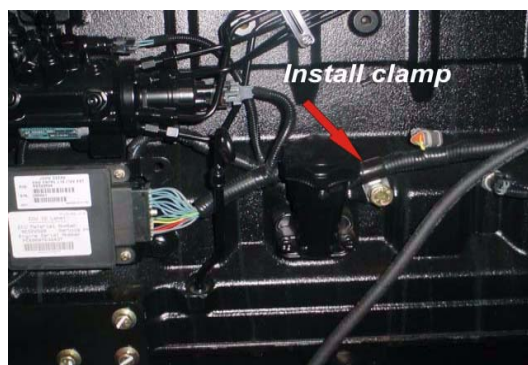
**FIG 1**

**Symptoms:** Unit fails to start, or shuts down unexpectedly

Order Kit CCN 23103385, which includes clamp 23084643 and bolt 96711908. Install bolt and clamp in engine block near oil fill. Push harness toward the ECU to relieve any tension on the ECU connector wires as shown in Figure 1.
