## Portable Compressor

**PC- 5-065**

## ENGINE SPEED CONTROL

**Models Affected:** P375WCU prior to S/N 303480

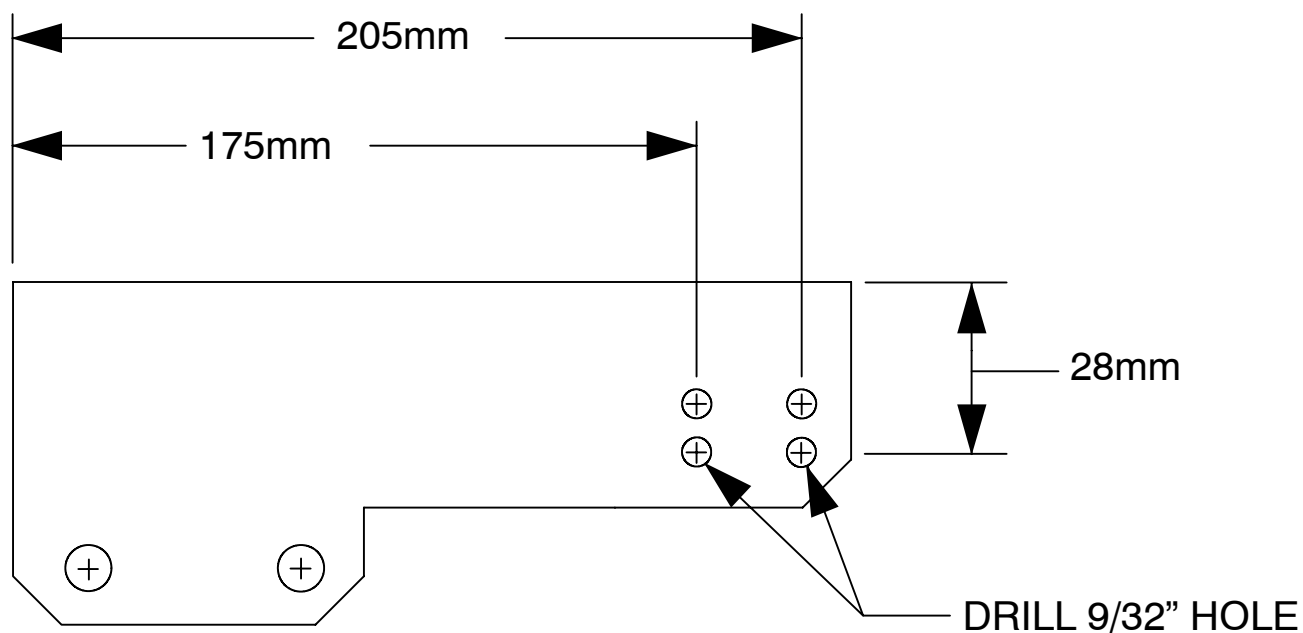
**Symptoms:** Low Engine Speed  
Excessive Engine Vibration  
Broken Throttle Lever on Engine Fuel Pump

**Cause:** Lack of Idle Speed Adjustment

**Remedy:** Remove air cylinder rear support bracket 36888113  
Locate and drill two 9/32 inch holes in bracket per drawing below.
