Portable Power Service News | Oil System

Scavenge System arrangement change 9/274-9/304-12/254-17/244-21/224

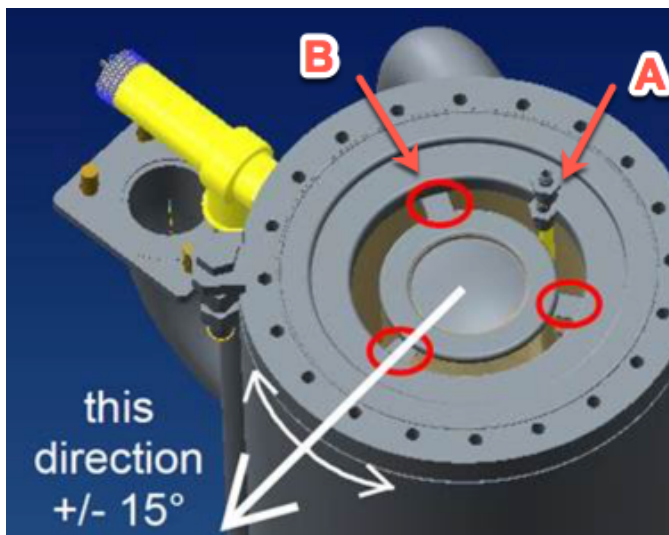
[Figure 1]

A - Scavenge pipe/hose
B – Filter support brackets

When installing the new pipe, please observe the location of the filter reinforcement brackets in relation to the scavenge pipe to ensure they do not make contact. (Figure 1)

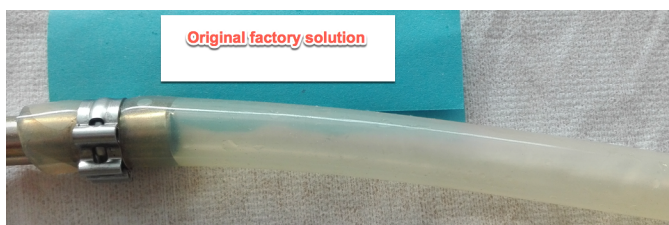
[Figure 2] original steel pipe+hose

From factory these scavenge systems had been assembled using a section of steel pipe connected to a plastic hose. (Figure 2)

It was however observed that there is a potential for increased oil carryover due to a defect of the plastic hose just below the connection with the steel pipe.
