Technical Service Bulletin

Bulletin #:	2006-002		Date:	05/07/06
Product:		☐ Generator	☐ Tools	
Subject:	Foam replacement on 7-51 rear canopy			
•				
Models				
7/51	SN 442041 - 442149

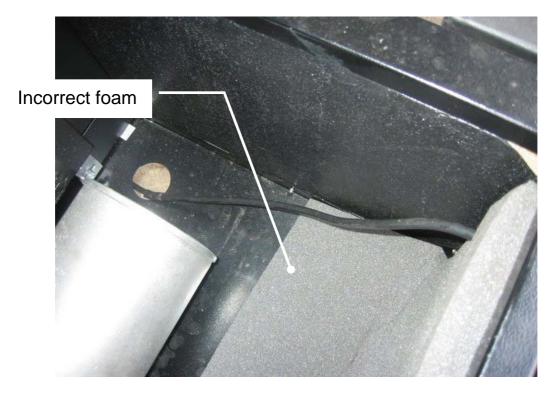
76 machines among the serial number range above have been fitted with not-to-specification insulation foam on the bottom of the fixed canopy. This foam can be recognised easily as it doesn't have a black protection layer on its surface, see photo. As a result dirt can accumulate and this foam will degrade quicker than the correct one.

We recommend replacing the foam with the correct foam panel CPN 54623335. Please advise how many parts you expect to replace in your territory in order for us to estimate the stock required.
